Subject: Douglas Battery Mfg Co.
NCD 003 213 030
Winston-Salem, Forsyth County, NC
Site Re-Assessment (SRR) Report

The following is a Site Re-Assessment Report (SRR) completed by the NC Superfund Section at the Douglas Battery Site in Winston-Salem, Forsyth County, NC. The purpose of this investigation was to re-evaluate the threat posed by this site to human health and the environment and to determine the need for additional action under CERCLA/SARA. Based on the re-assessment results, the NC Superfund Section recommends that this site's No Further Remedial Action Planned (NFRAP) status remain unchanged.

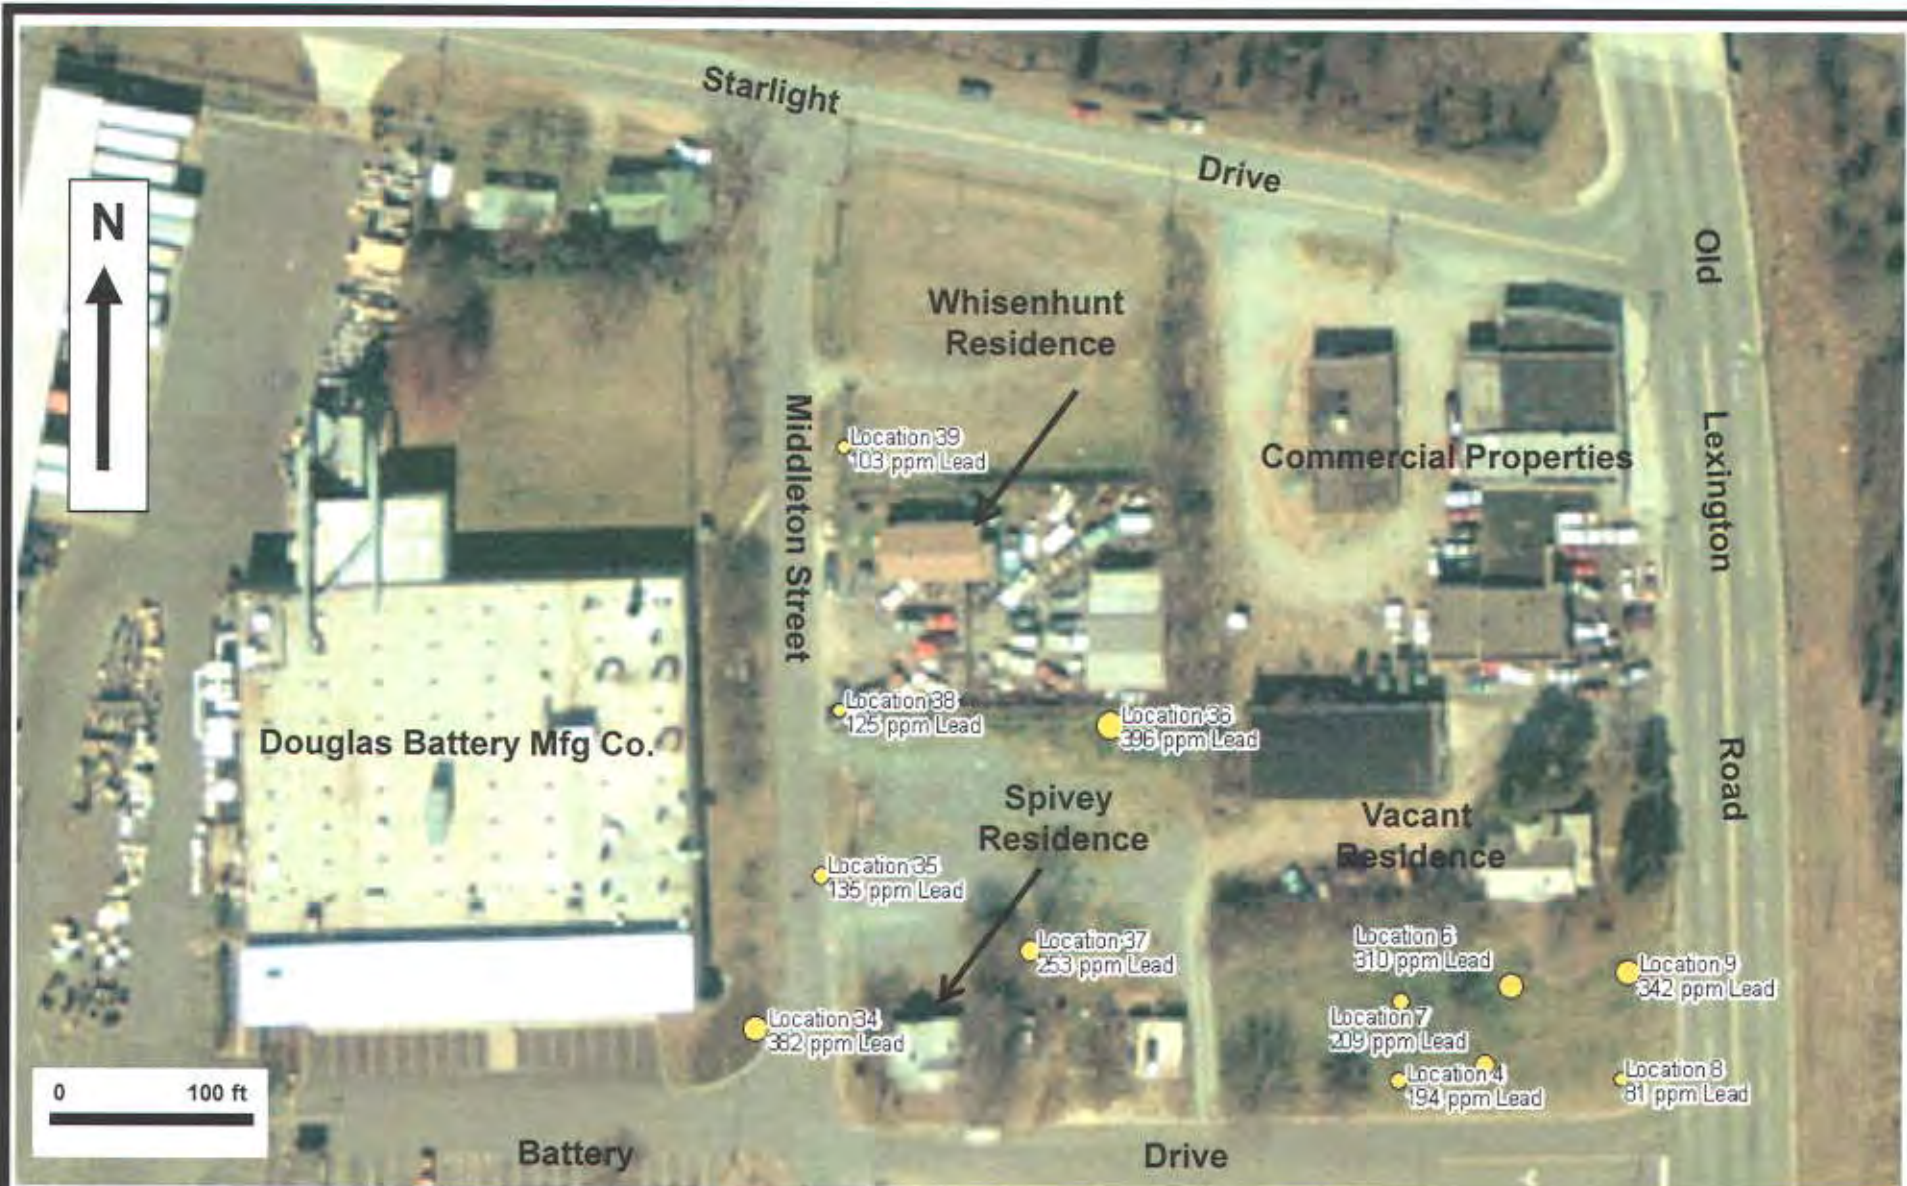
FIGURE

X-Ray Fluorescence Soil Screening - North

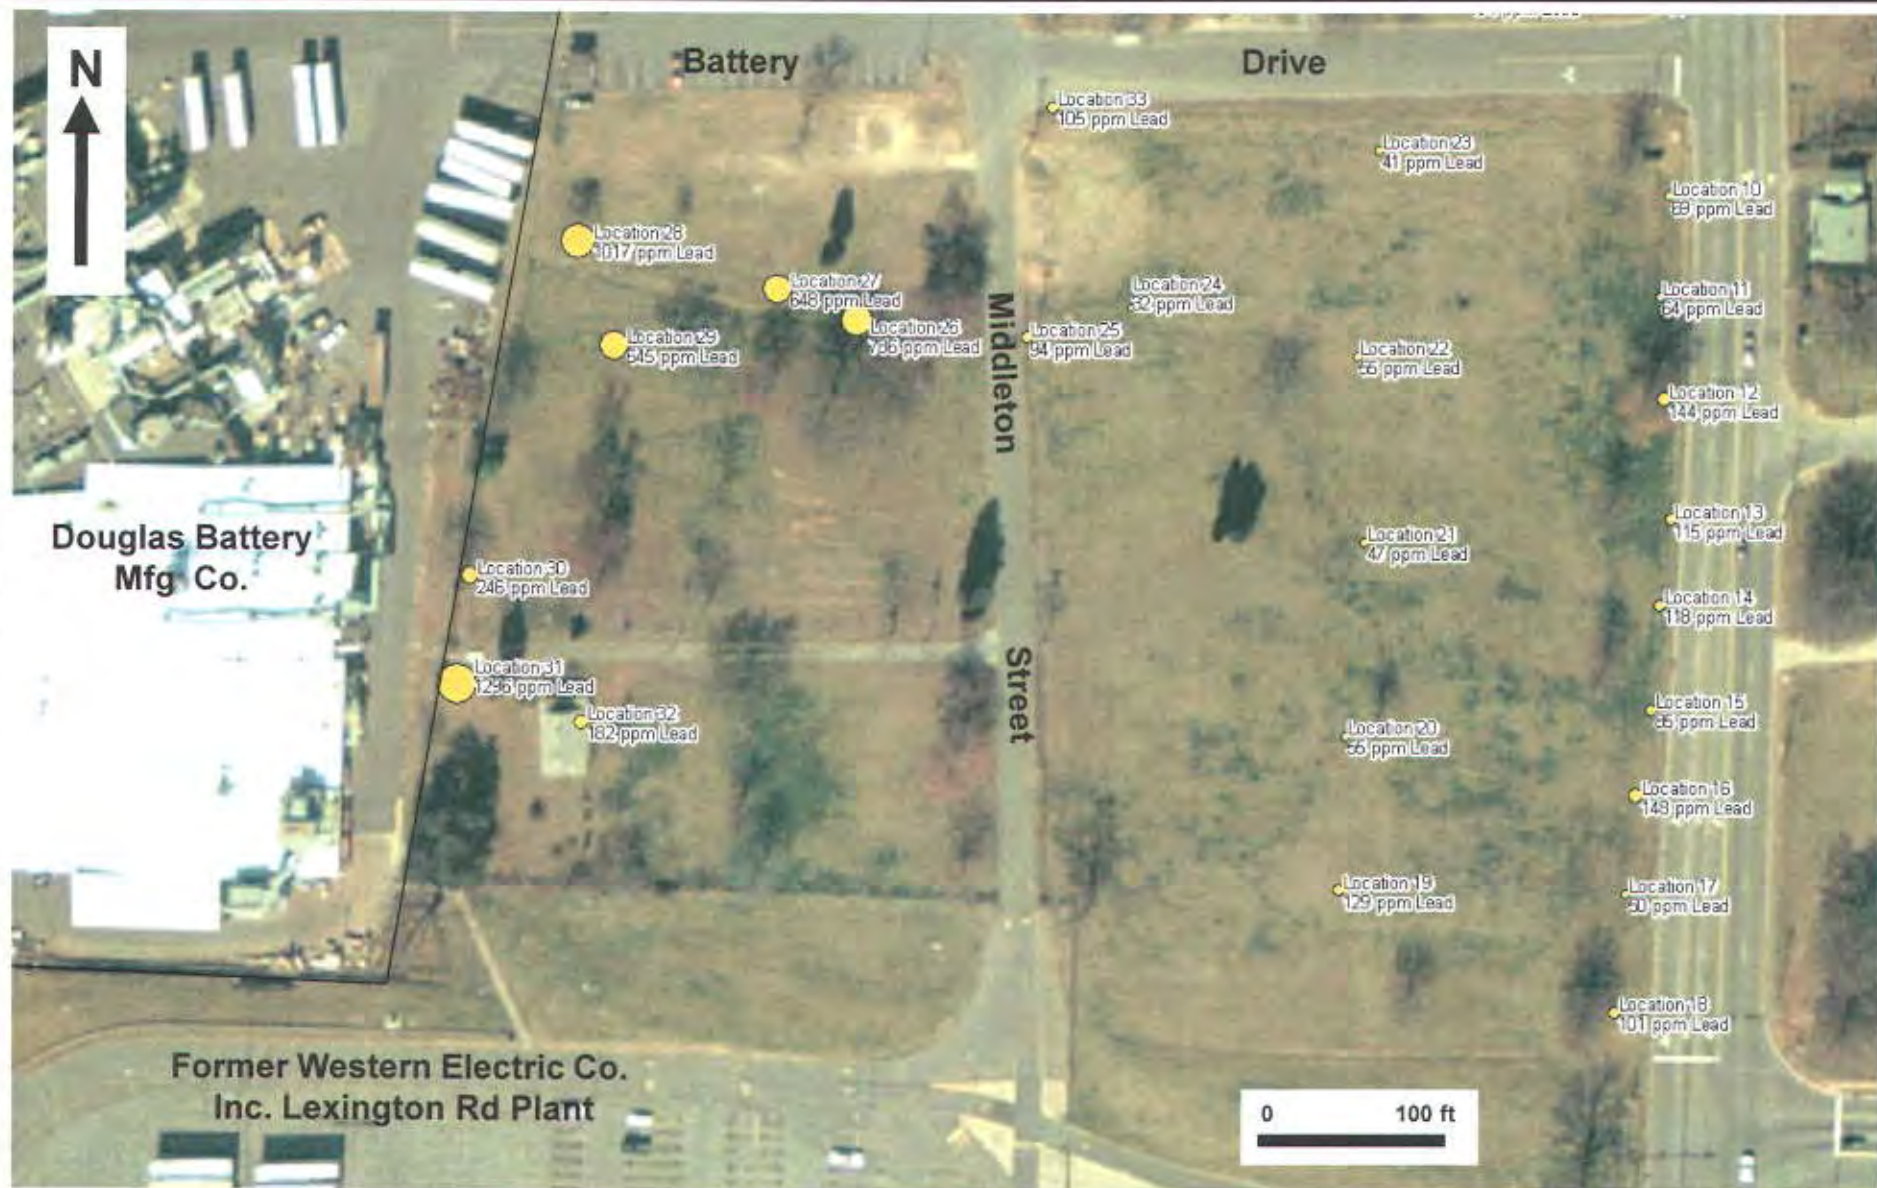
FIGURE
3B

X-Ray Fluorescence Soil Screening - South

Yellow symbol size is proportional
to soil screening lead concentration
as measured by X-Ray Fluorescence.

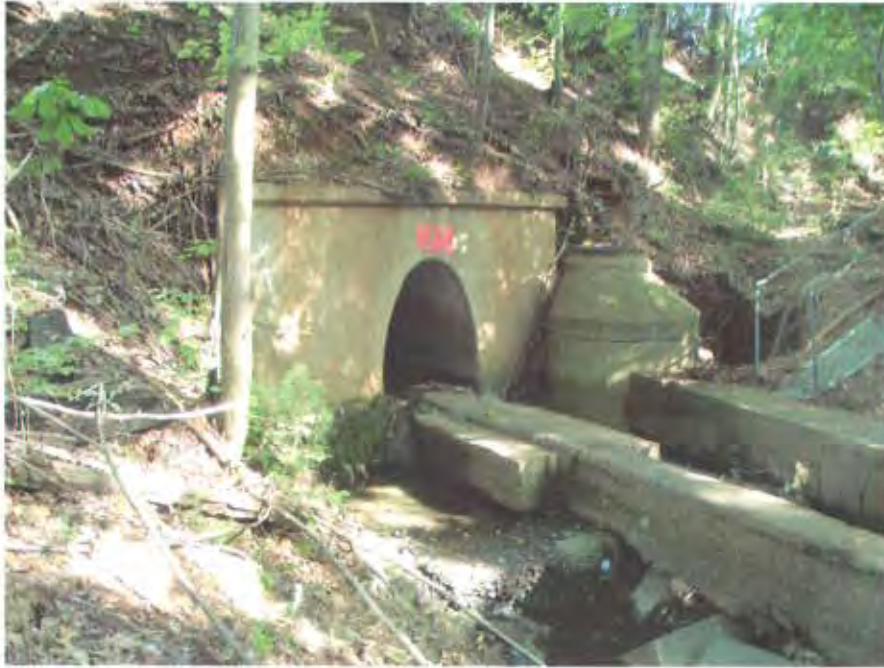
Photo 3: Douglas Battery storm water outfall at railroad on west side of property.

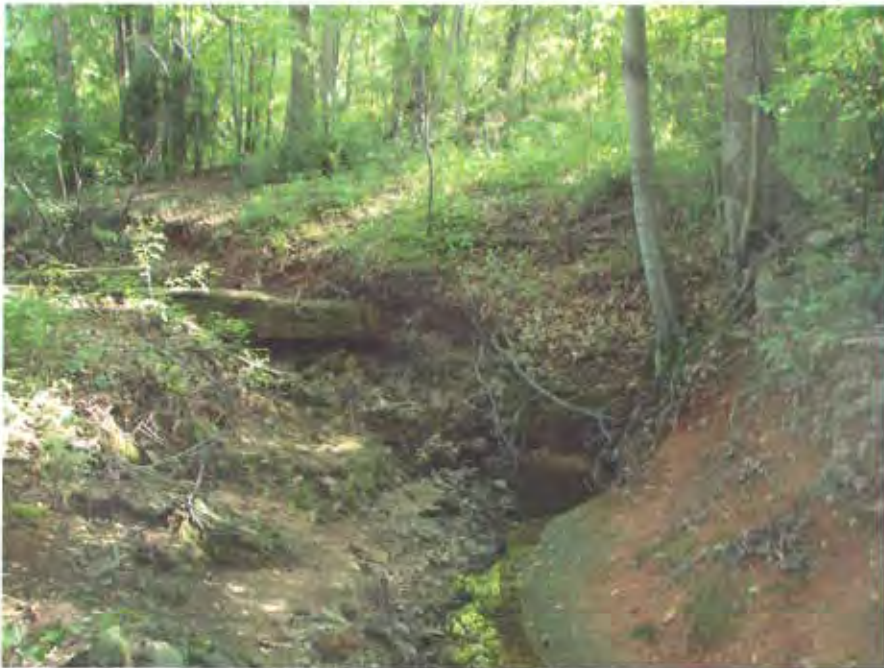
Photo 4: Location 40 - XRF sediment screening below storm water outfall.

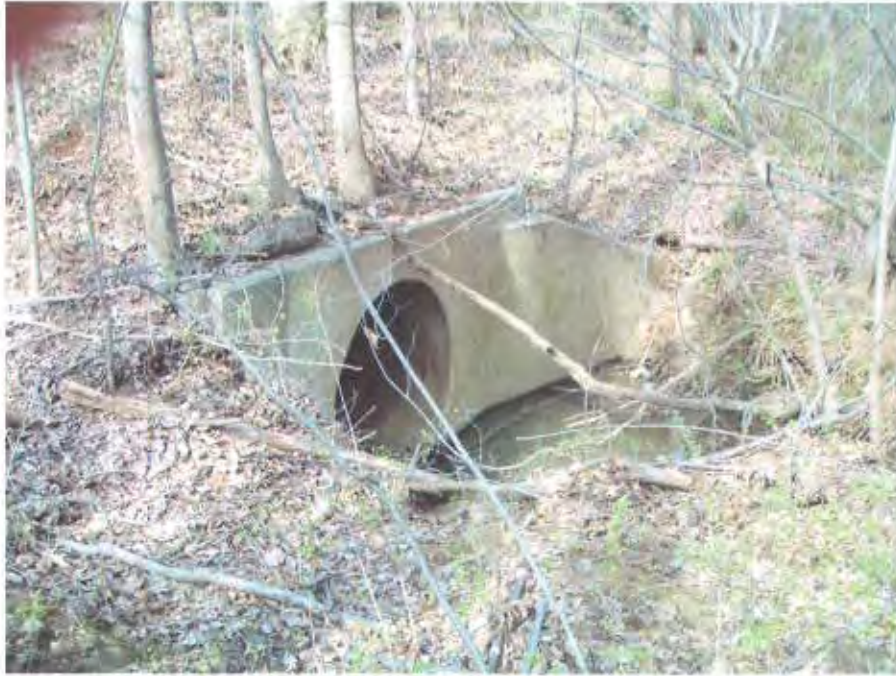
Photo 5: Storm water culvert entrance beneath Starlight Dr.

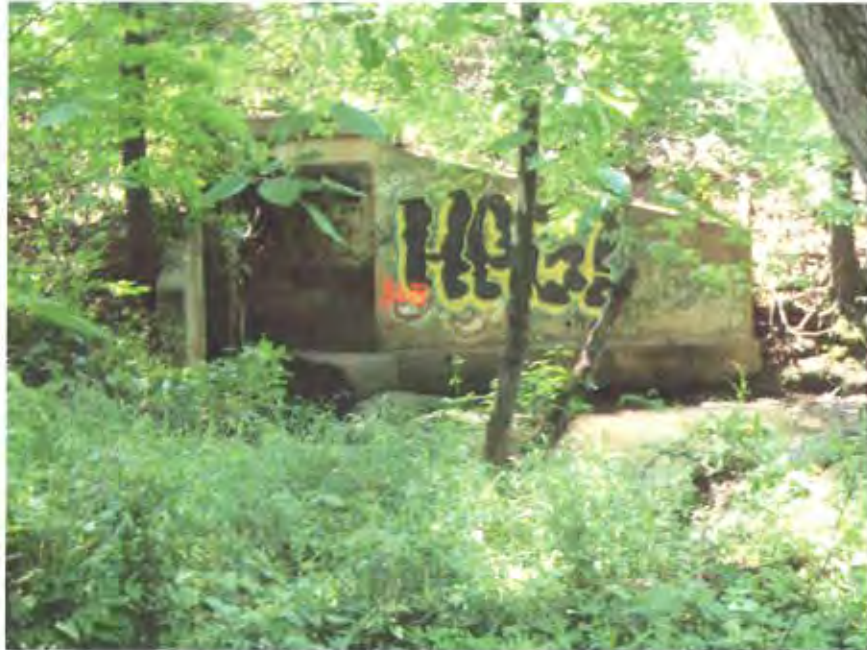
**Photo 6: Storm water culvert exit northwest of I-40/US-52 interchange.
Location 2 – XRF sediment screening above PPE to Parkway Branch.**

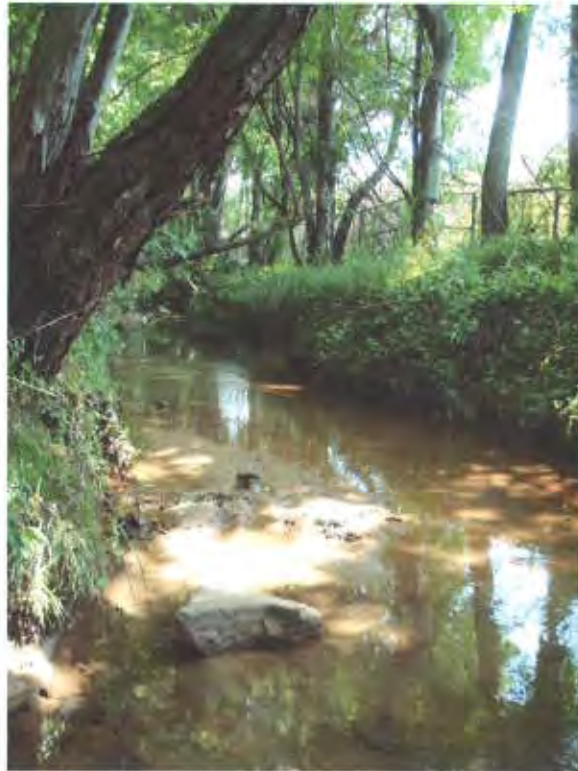
Photo 7: Parkway Branch segment, upstream from PPE and north of I-40/US-52 interchange. Locations 1 and 3 - Background XRF sediment screening.

A background segment of Parkway Branch lies upstream from the PPE, on the north side of the I-40/US-52 interchange. This background section receives surface runoff from a paved area, the former parking lot of a textile mill which historically operated to the north (Ref. 5; Ref. 7; Fig. 2B). The textile mill was replaced by a school which uses the paved area for supervised student recreation. The paved area is partially fenced and its road access gated and locked to restrict public access. NC Superfund Section personnel observed no evidence of fishing or other activity near the PPE, except for graffiti on the nearby highway culvert (Ref. 5).

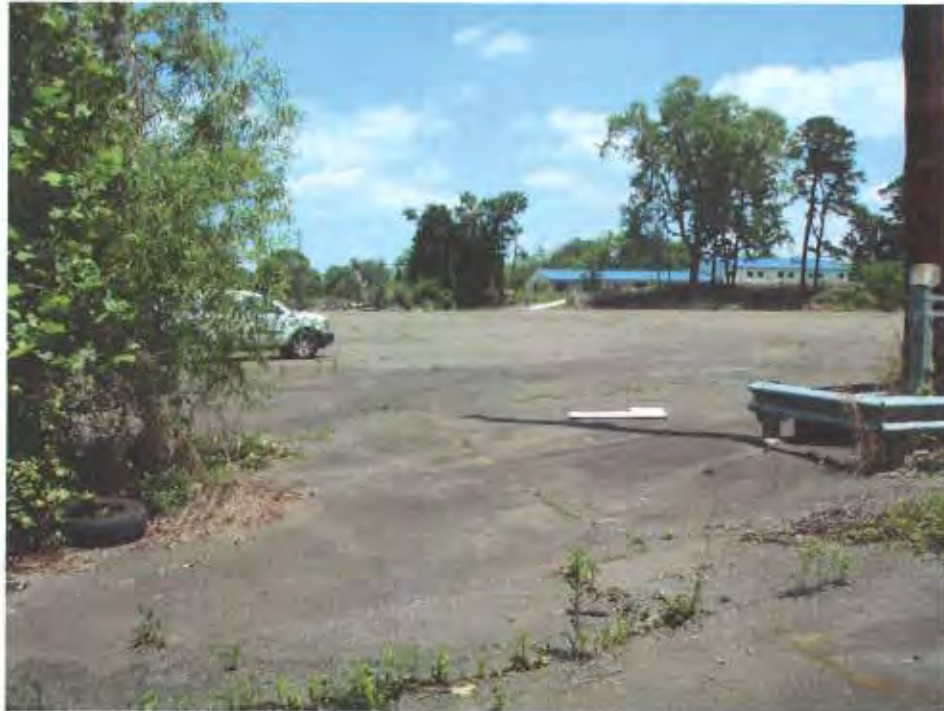
Photo 8: Former textile mill parking lot used as school playground, up gradient (north) from background Parkway Branch segment.

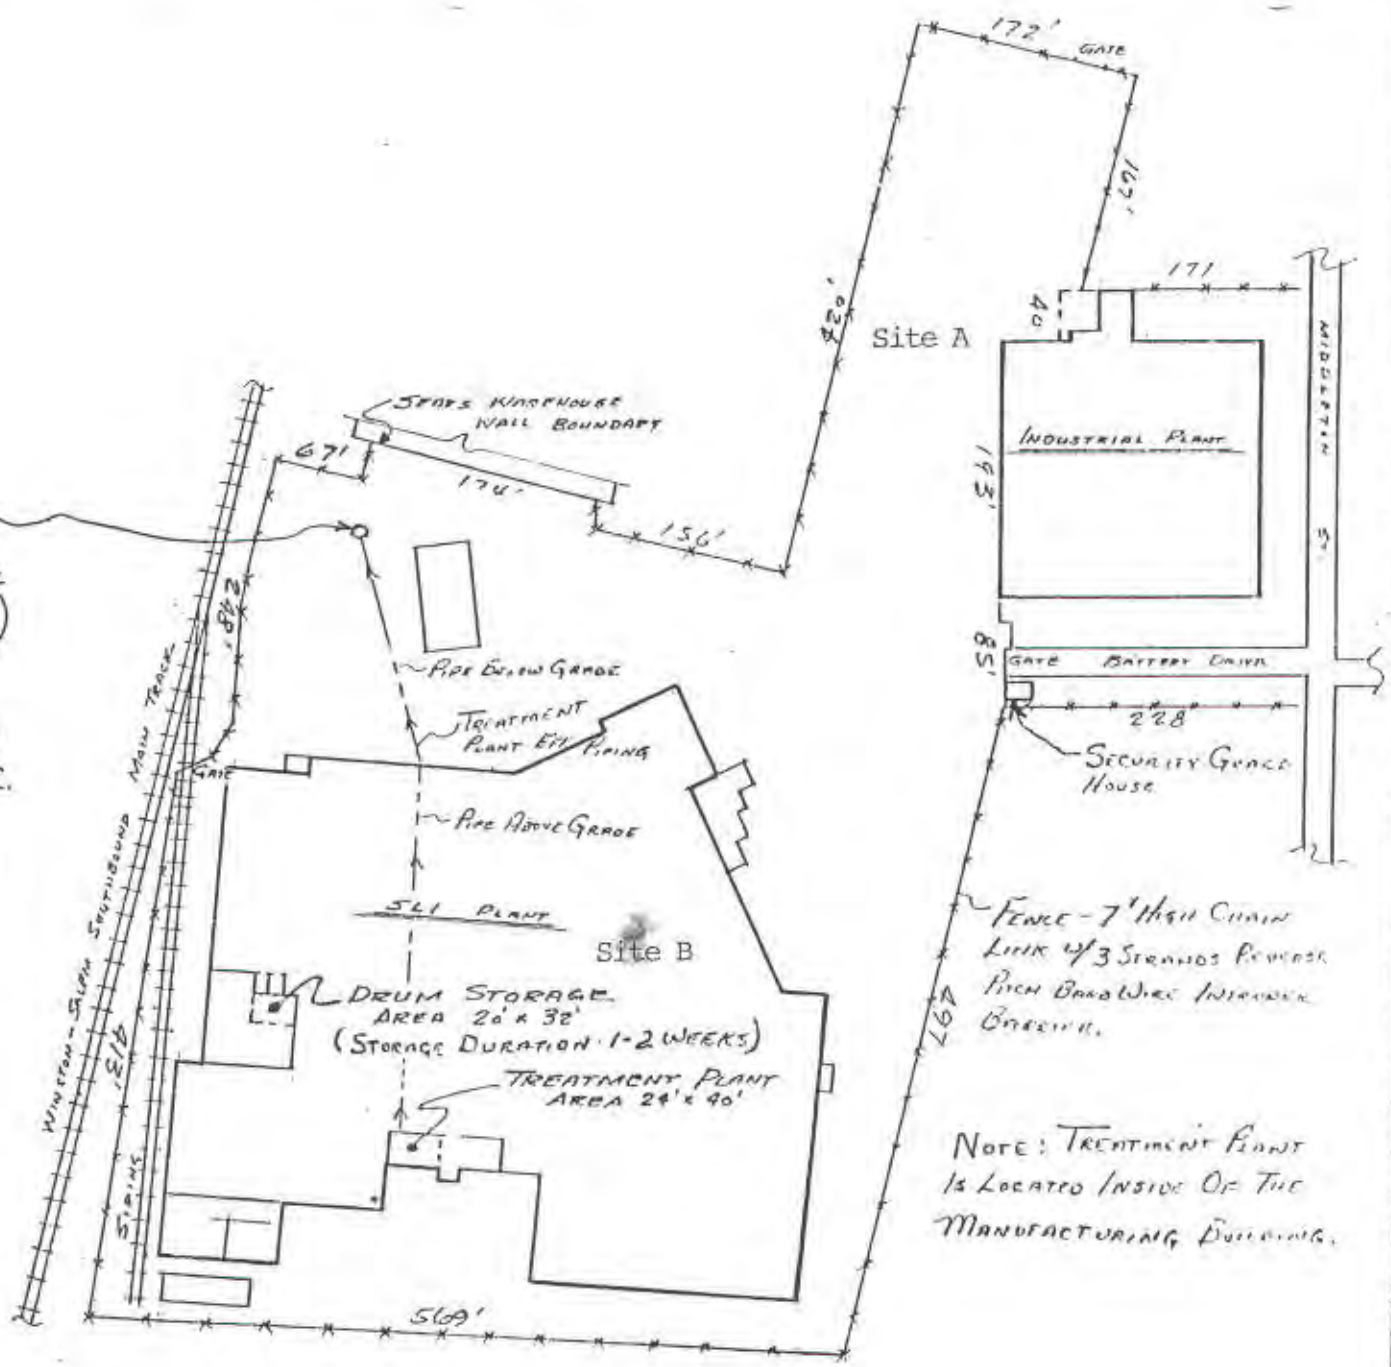
FENCE - 7' HIGH CHAIN
 LINK 4/3 STRANDS PEWEEB
 HIGH BOND WIRE INTERIOR
 BOUNDARY.
 NOTE: TREATMENT PLANT
 IS LOCATED INSIDE OF THE
 MANUFACTURING BUILDING.

DOUGLAS BATTERY
 SCALE 1"=150'

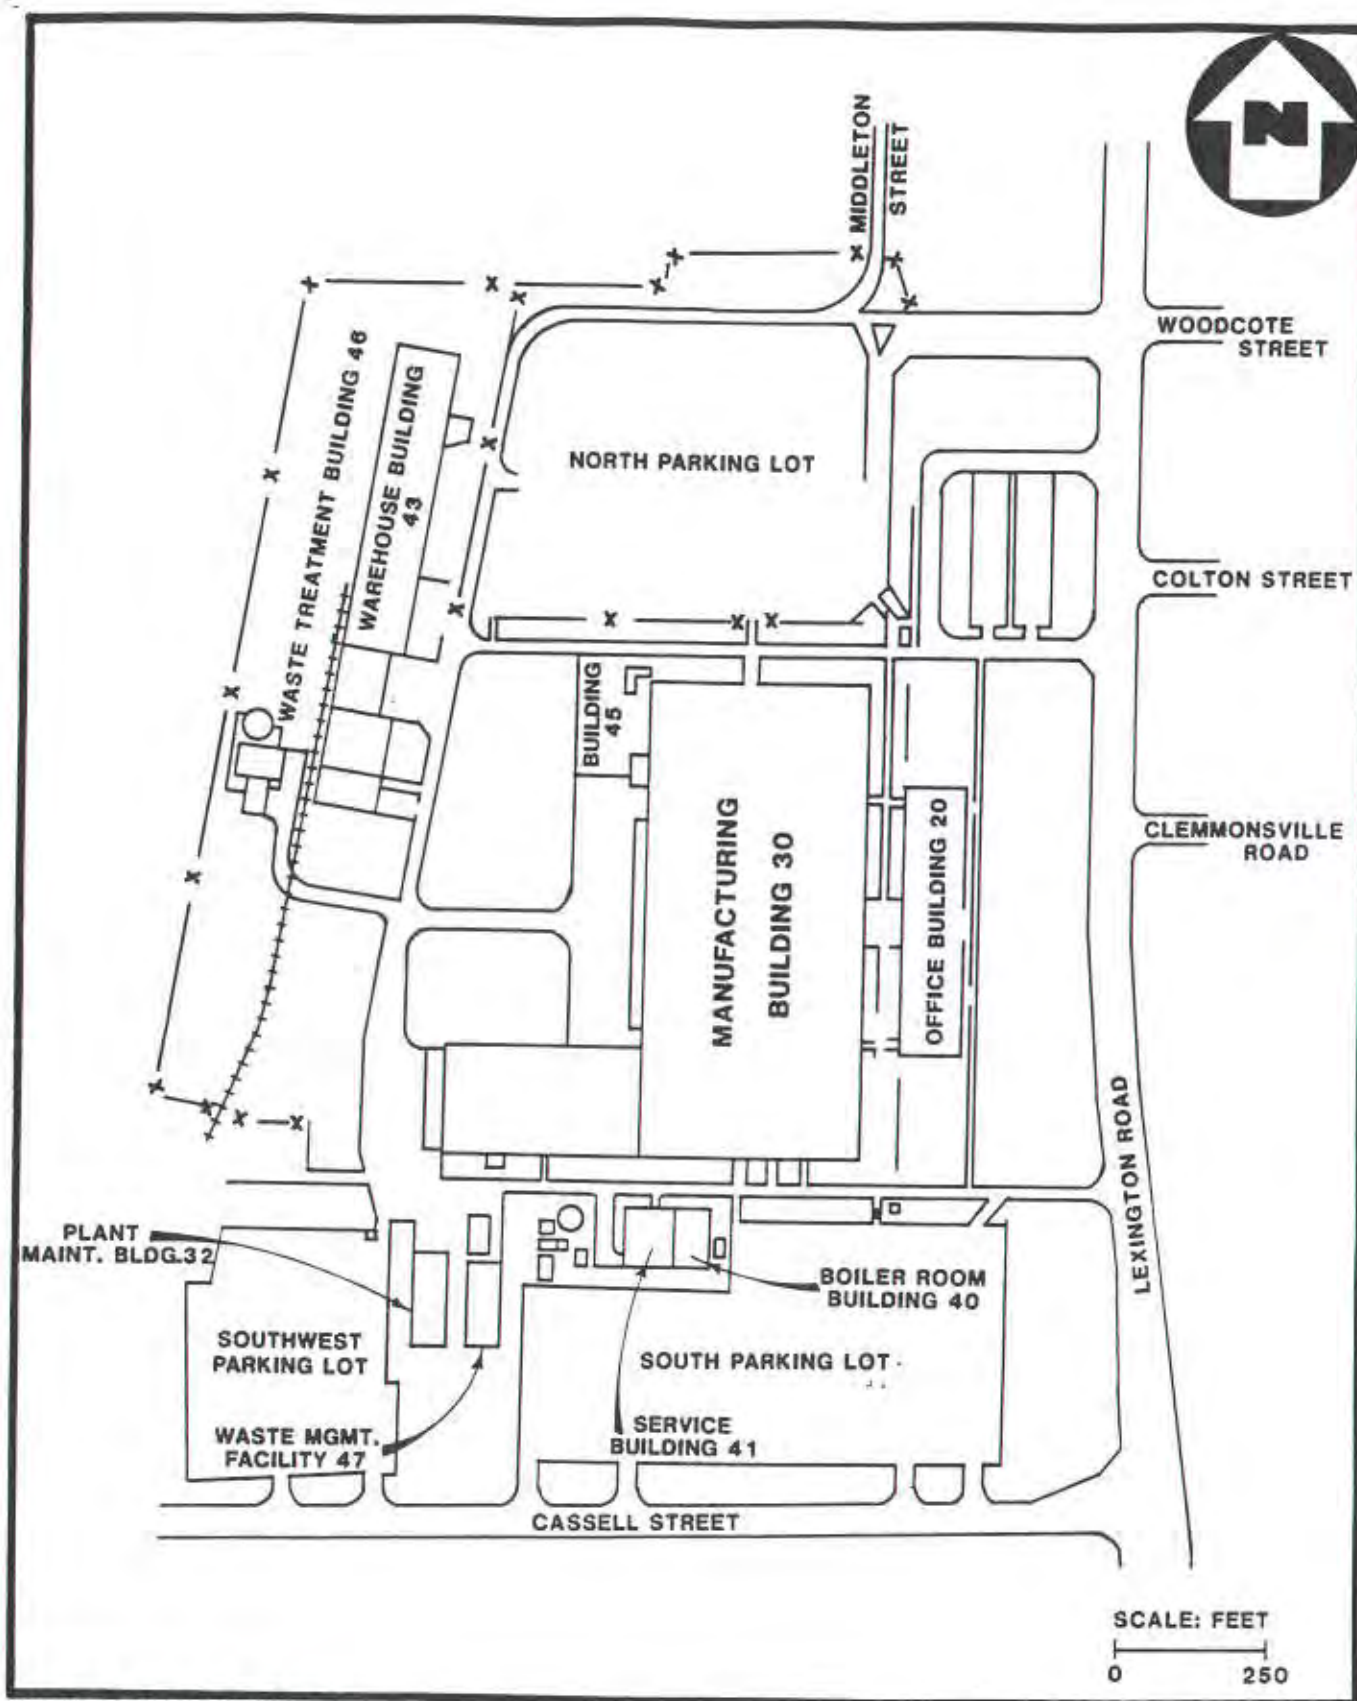
FIGURE 2-1

SITE LAYOUT MAP
AT & T TECHNOLOGY
WINSTON SALEM - NORTH CAROLINA

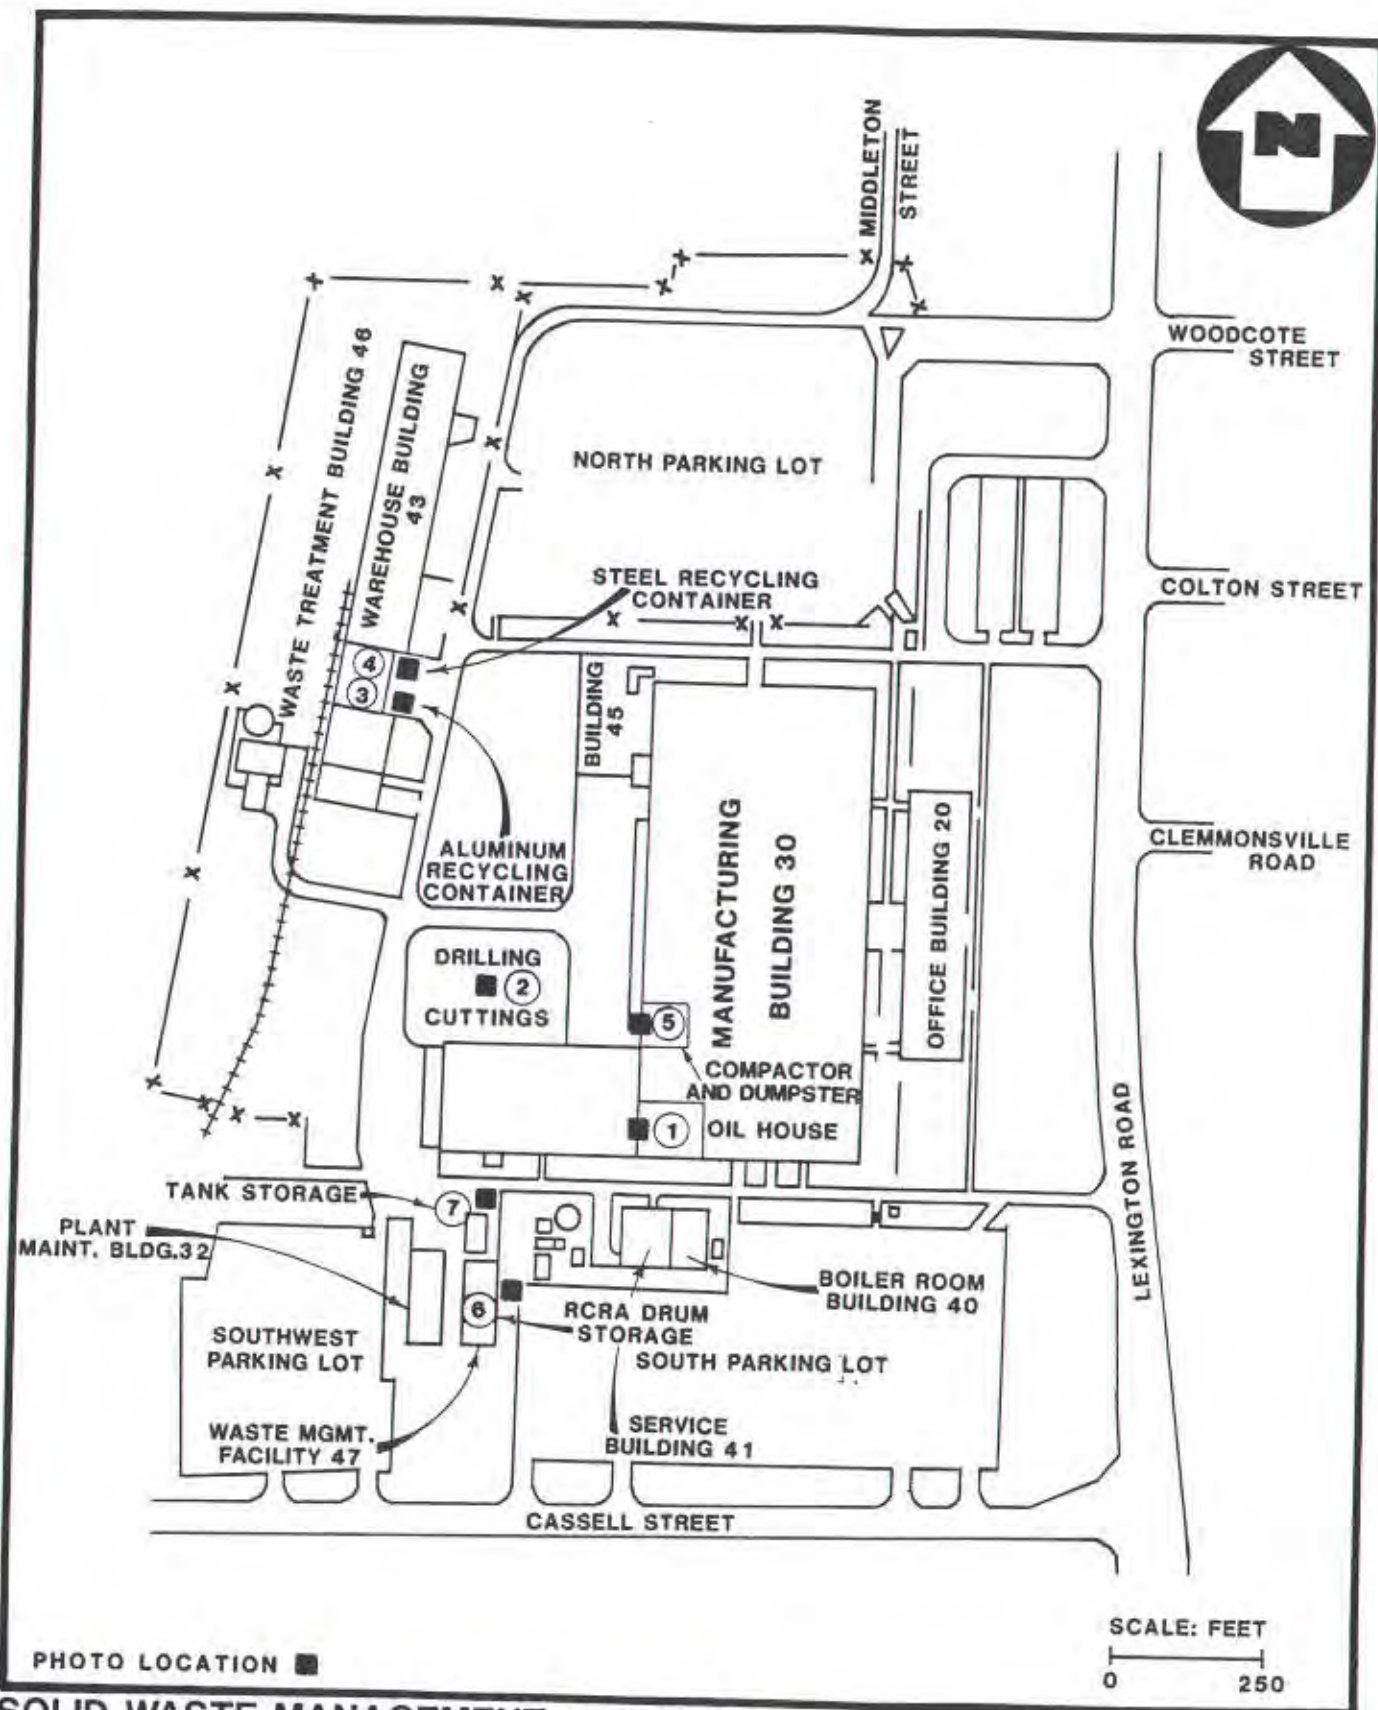
FIGURE 4-1

**SOLID WASTE MANAGEMENT / AREA OF
CONCERN / PHOTOGRAPH LOCATION MAP
AT & T TECHNOLOGY
WINSTON SALEM - NORTH CAROLINA**
